C13 Case Study: Throttle Malfunction in a 2004 Ford Escape

Eric R. Miller, BSE, PO Box 7337, Tempe, AZ 85281*

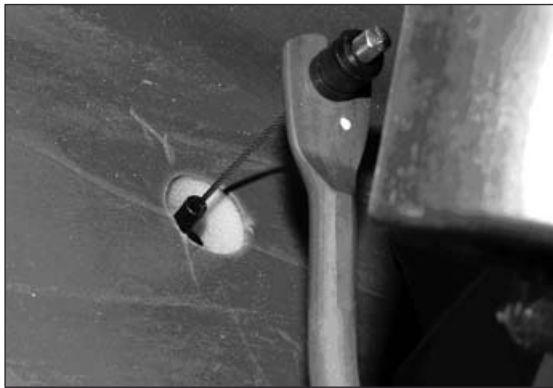
Inspection of the subject vehicle confirmed that the accelerator pedal was stuck in an applied position. The recall dealt with migration of the inner lining at the dash panel fitting however, as shown in Figure 1, the cable appeared to be intact. The cable was inspected from its insertion point in the firewall to the termination point on the throttle body and was found to be free of bends, twists or kinks that may have prevented the accelerator pedal from returning to its fully released position.

Figure 1: Accelerator cable at firewall and accelerator pedal installation point.

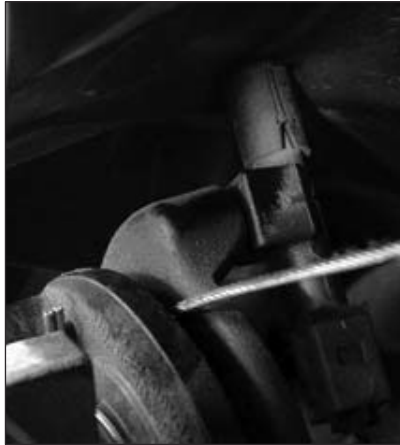
However, Figure 2, it appears that the throttle position sensor became caught on the underside of the plastic engine cover, thereby preventing the throttle body pulley/spring combination from rotating which prevented the taking up of slack in the accelerator cable. This not only prevented the accelerator pedal from returning to its fully released position, but also kept the throttle plate (located inside the throttle body) open.

Figure 2: Throttle position sensor entrapment at plastic engine cover.

Since the subject vehicle had been serviced under the above mentioned recall, it is not known if the pulley was able to rotate to the position shown in Figure 2 due to an error during the installation of replacement cable, a difference in the length of the pre- and post-recall accelerator cables, or some other factor. The accelerator cable was not released from this position, and therefore an attempt to replicate the circumstances that led to the throttle position sensor becoming trapped on the plastic cover was not conducted.
