Engineering Sciences Section – 2010

C1 Pickup Rear Bumper Damage Patterns and Force-Deflection Characteristics

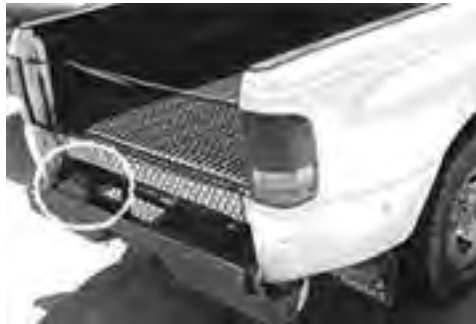
Figure 1, Post Collision Photograph of the Pickup.

Post-repair inspection of the pickup revealed the absence of the side braces between the bumper ends and the brackets. In post-collision photographs, before repair, the side braces were not visible, as seen in figure 1 above.

Given the apparent absence of side braces, it was theorized that the loosening or removal of the bolts that connect the bumper to the bumper brackets could result in the enhanced downward appearance of the pickup rear bumper, thereby exaggerating the appearance of the damage as was alleged by the SUV driver. Indeed, as shown in Figure 2, the photographs of the SUV fail to reveal the type of under-ride damage that would ordinarily be associated with the pickup's rear bumper deflection.

Post-test examination of the bumper brackets revealed that the presence of the side braces forced the bumper brackets to bend just ahead of the brace attachment in a characteristic manner. As viewed from above and behind the bumper, only the narrow bent portion of the bumper bracket was visible between the bumper and the cargo bed, as depicted in figure 1 above. Therefore, the post-collision bumper damage was replicated with an intact bumper assembly.

As such, it can only be concluded that the post-collision appearance of the pickup did not depict a bumper position that was exaggerated by removal or loosening of bumper to bracket mounting bolts and side braces. Indeed, the SUV's head light and grille area damage confirms that it forced the pickup's rear bumper to roll under to the extent depicted in post-collision photographs. However, the pocketing of the pickup's rear bumper step prevented the under-ride type damage that would ordinarily result.

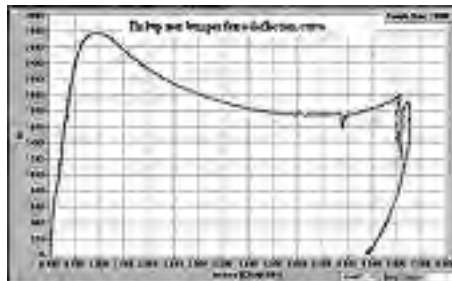
Figure 3, Force-deflection of the Pickup's Rear Bumper. Shown above is the force deflection collected on the fourth test.

The first three tests were halted due to winch mounting, chain slipping, or instrumentation interference issues. Test numbers two and three resulted in similar initial curves before the tests were halted. Between tests the damaged brackets, etc. were replaced. Integrating the above force-deflection curve for the work required to cause this damage resulted in a velocity change of nearly 3½ mph.
