### C37 Using CT Scans to Identify the Mechanism for Left-Sided Skull Fracture From a Right-Sided Broadside Collision

Robert D. Anderson, MS\*, *Biomechanics Analysis, PO Box 7669, Tempe, AZ 85281-0023*

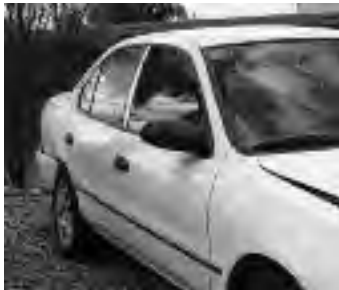
Figure 1, Rear Wheel Area Damage After Partial Repairs

The sedan pictured above sustained a right-sided broadside collision centered about the right rear wheel. Using the vehicle damage and post-impact vehicle motion, the lateral Delta V was estimated to be within the approximate 10 to 12 mph range.

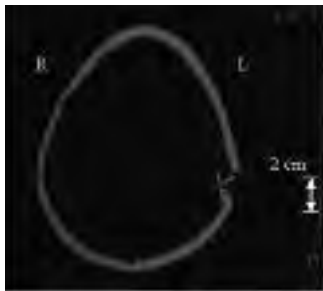
With right-sided occupant strikes, the mechanism for injuries from right-sided blunt trauma is clear. However, as shown in figure 2, the driver sustained a left-sided skull fracture. The narrow punch-out type appearance of the fracture confirms that it was caused by forceful contact with a narrow object that was partially penetrated the skull.

Figure 2, CT Image Showing Left Skull Fracture

Using the scale shown in figure 2, the object that caused the skull fracture was about  $\frac{3}{4}$  inches or 2 cm wide. As shown in figures 3 and 4, the knob for the adjustable D-ring was not only aligned with the fracture site, but it was also about  $\frac{3}{4}$  inches wide.

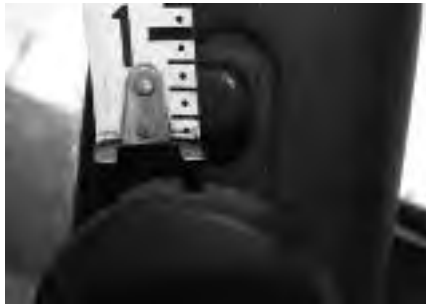
Figure 4, Width of D-Ring Adjustment Knob

With this evidence it can only be concluded that the driver sustained a left-sided skull fracture from striking the D-ring adjustment knob during leftward rebound-type motions immediately following the right-sided broadside collision.
