C6 The Importance of Proof Marks in Vehicle Accident Reconstruction

Michael L. Shirley, BS*, *Innovators Research, Inc., 2290 CR 23, Waterloo, IN 46793-9415*

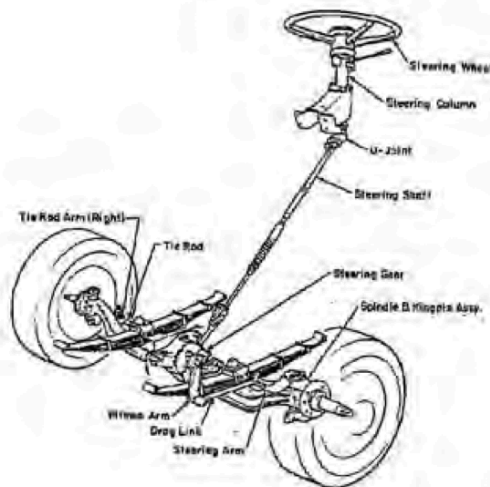
pictorial representation of a typical heavy duty commercial vehicle steering system is presented in Fig. 1 for reference.
