## C21 *In-Situ* Hardening of a Steel Tank: Carbon Diffusion Over 35 Years at Ambient Temperatures

Anastasia Micheals, MS\*, Forensic Materials Consulting, 1784 Sanchez Street, San Francisco, CA 94131-2741

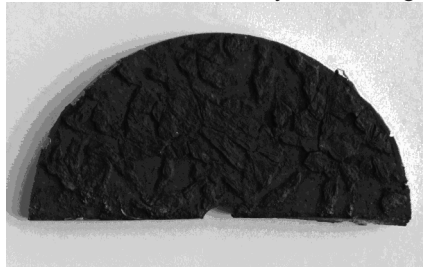
Under the optical microscope, a cracked, black coal tar pitch epoxy coating was observed on un-cleaned *A* (Figure 1). In some areas, the coating had spalled away, and, in the presence of both air and water, red iron oxide scale formed. *A* was then examined by scanning electron microscopy, in a region containing both coating and corrosion (Figure 2). The corrosion has an appearance typical of iron oxide (Figure 3). The coal tar coating (Figure 4) shows some surface deposits. It also shows a typical surface crack in the coating.

Figure 1. Water tank specimen, **Piece A**, no cleaning.

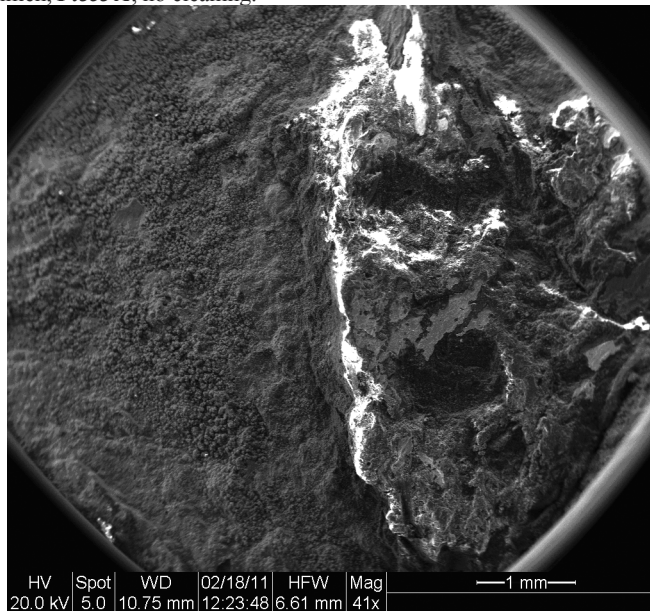
Figure 2. Electron micrograph of **A**, in a region with both red iron oxide corrosion and pitch epoxy coating.

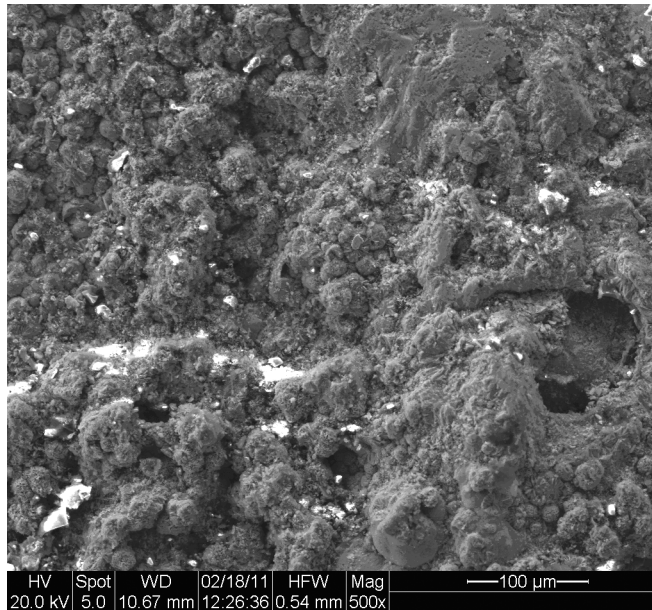
Figure 3. Electron micrograph of corrosion from *A*. The bubbles are typical of rust; EDS analysis confirmed the composition of the rust to be  $Fe_2O_3$ .

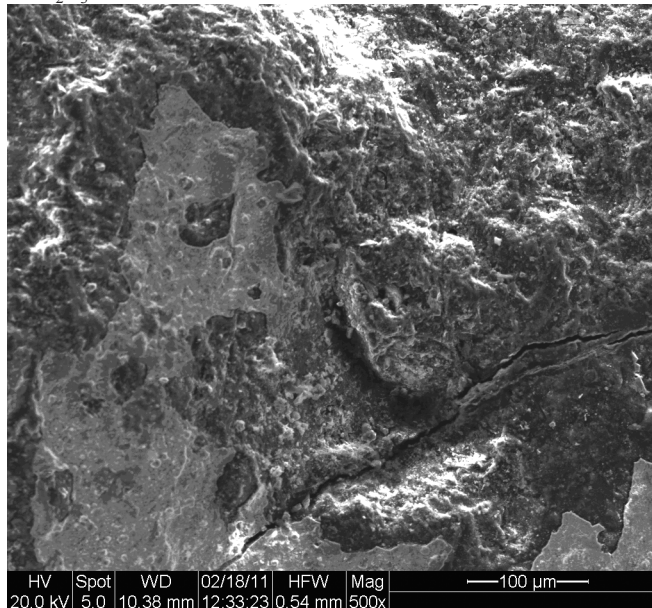
Figure 4. Electron micrograph of the pitch epoxy coating from *A*. The light areas are surface deposits. The crack is typical of those found in the coating.

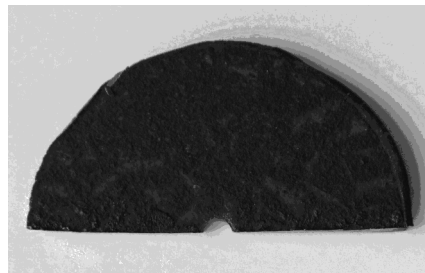
Optical microscopy of *B* showed that the sweep blasting, while incomplete, had removed most of the coal tar coating (Figure 4). Residual red iron oxide was observed, as well as some black regions that were consistent in shape and density with the coal tar coating seen on the un-cleaned piece. *B* was examined in the SEM. The surface was somewhat rough, indicating incomplete sweep blasting. EDS of the area again revealed no unexpected elements.

Figure 4. Water tank specimen, *Piece B*, sweep blasted.

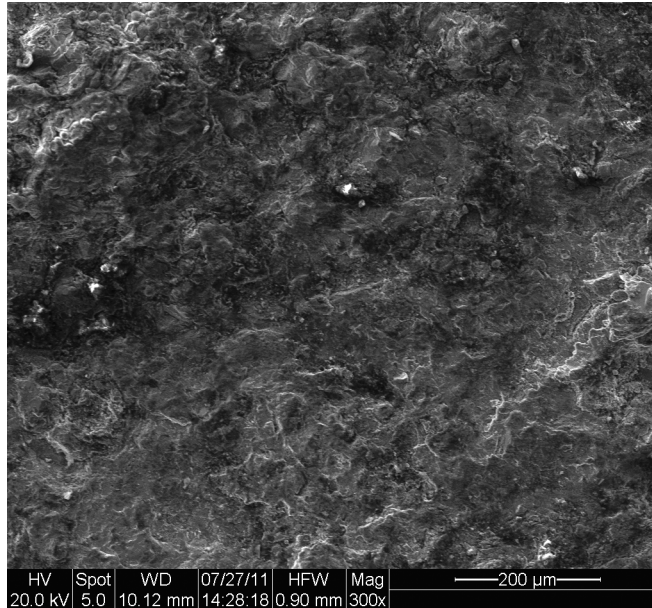
Figure 5. Electron micrograph of **B**. The rough surface is a result of sweep blasting with steel abrasive, which did not penetrate to the steel substrate.

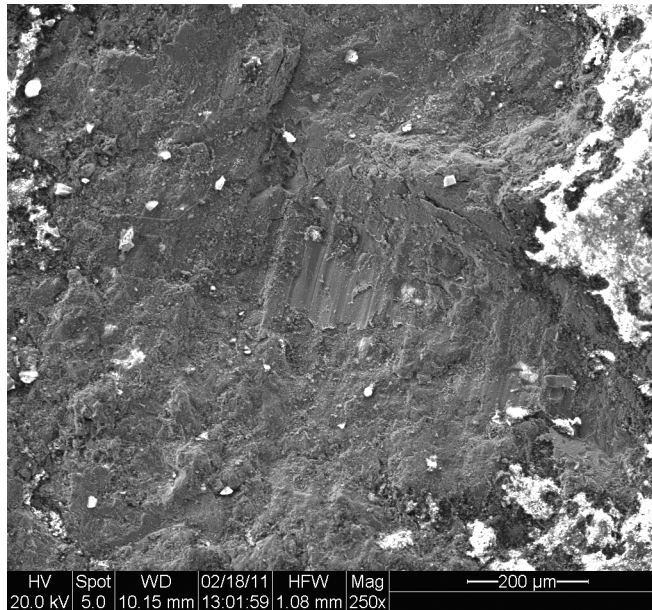
Figure 6. Area of EDS analysis.

Spot elemental analysis was performed on an area of sweep blasted *B*, where a cross-section from the pitch coating to the bare steel was visible (Figure 6). Elemental measurements were made at three locations; pitch coating, mid coating, and bare steel. The analysis results are summarized in Table 1. The additional elements detected, likely deposits from groundwater, are silicon, calcium, aluminum, magnesium, potassium, sulfur, and chlorine.

At Spot 1, the top of the coating, carbon from the coal tar pitch epoxy was detected. Hydrogen is also likely present, although the EDS technique cannot detect it. At Spot 2, a significant amount of iron was detected, in addition to carbon and oxygen. The ratio of iron to oxygen is approximately 1:1, which suggests iron oxide of the form FeO, a black oxide. The presence of carbon suggests carbon diffusion into the iron oxide. At Spot 3, the primary element present is iron. The oxygen present may be due to debris from the sweep blasting process. A very small amount of carbon is present as well.

**Piece B** reveals a second process occurring, that of carbon diffusion. Carbon will readily diffuse into iron, at a rate dependent on temperature. The carbon gradient discovered in Piece B indicates that the carbon diffusion process has been taking place over the 35-year lifetime of the tank. Although the maximum ambient temperature was relatively low (~100° F), the long time allowed significant carbon diffusion to occur, causing surface hardening of the low carbon steel. This diffusion rate was verified by Fick's Second Law.

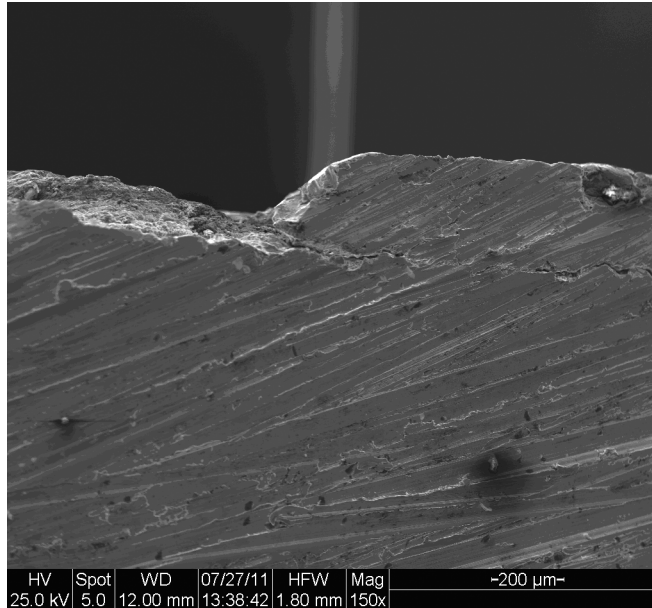
or contracted with changing ambient temperature. Water then penetrated through the cracks to the steel, and formed ferrous oxide (FeO), the iron corrosion that forms in limited-oxygen environments. The corrosion propagated underneath the coating (Figure 7); the corrosion continued underneath the coating, allowing pieces to spall off. The iron, then exposed to oxygen from the air, converted from black FeO to red Fe<sub>2</sub>O<sub>3</sub>.

Figure 7. This cross section shows the propagation of corrosion beneath the coating.  
**Diffusion of Carbon in Steel, Oxidation, Corrosion**
