C19 Forensic Analysis of a Seat-Belted Occupant Ejection in a Rollover Collision

Kurt D. Weiss, MS*, Automotive Safety Research, 5350 Hollister Ave, Ste D, Santa Barbara, CA 93111-2326

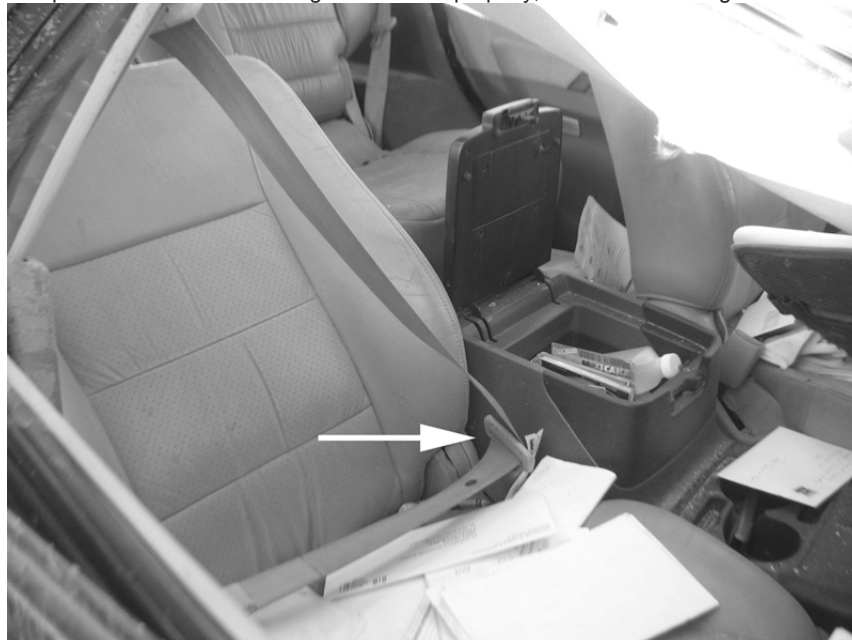
Based on stress marks observed on the driver's seat belt webbing, investigators concluded the driver was wearing the seat belt. The right front seat belt was found still buckled at the scene (Photograph 1), and the webbing did not reveal any type of stress marks. Although the investigators agreed the right front occupant was ejected, they concluded this occupant was either not wearing the seat belt properly, or was not wearing the seat belt at all.

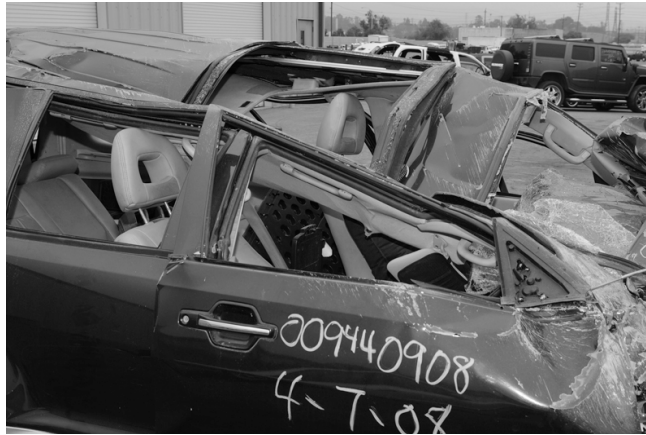
Incident Vehicle Examination: Significant roof crush and corresponding occupant compartment intrusion is consistent with a driver's side leading rollover event (Photograph 2).³ The left rear tire was examined and showed a near complete tread belt separation. Localized damage was observed around the left rear wheel well, on the rear bumper fascia, and exhaust system. Part of the tread belt was found still wrapped around the rear axle.

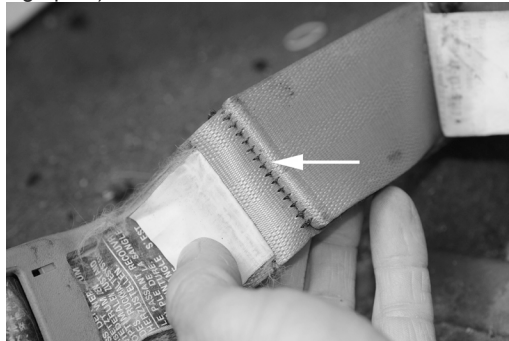
The right front seat belt features an expansion loop concealed under a rubber-like sleeve approximately 10in long.⁴ Close examination of the first row of stitches revealed these stitches were under tension applied during occupant restraining forces (Photograph 3).

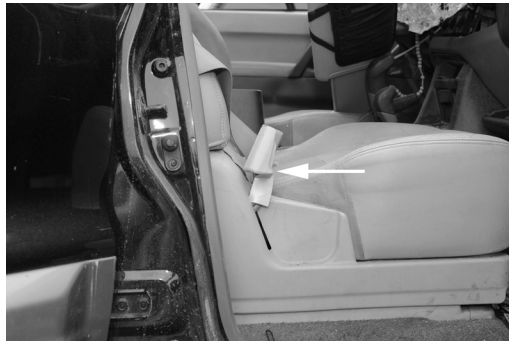
Upon further examination, the seat back assembly was found to recline without much effort. That is, the seat back recline mechanism was not locked. The seat back recline angle adjuster is on the outboard side of the seat cushion. Pulling the lever upward allows the seat back to recline. This recline lever was found to be substantially deformed (Photograph 4).

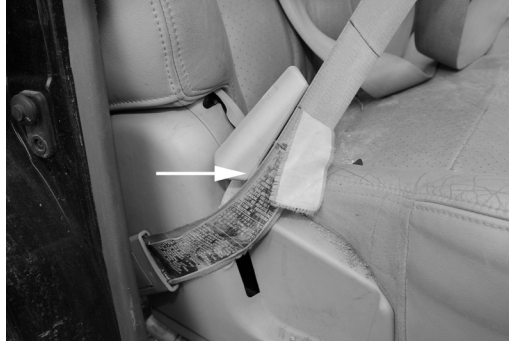
When the right front seat belt is stowed, the webbing is nearly vertical, but when fastened the expansion loop sleeve rotates forward about the lower outboard anchor bolt. It was discovered that the rubber-like expansion loop sleeve will cause the potential for the seat belt webbing to route under the seat back recline lever (Photograph 5).

Exemplar Vehicle Examination: A similar model year exemplar vehicle was located by random selection. The right front seat cushion position of the incident vehicle was duplicated in the exemplar vehicle. When a right front occupant fastened the exemplar seat belt, the webbing caught on the tip of the recline lever. Remarkably, after the retractor was manually locked and the right front occupant rose up from the seat to put the lap belt in tension, the recline lever was actuated and the right front seat back unexpectedly reclined. The exemplar vehicle demonstration helped explain the chain of events that led to the seat-belted occupant ejection in a rollover collision.
