C13 Forces in Vehicle Side-View Mirror Collisions

Russell L. Anderson, MS*, PO Box 7185, Tempe, AZ 85281

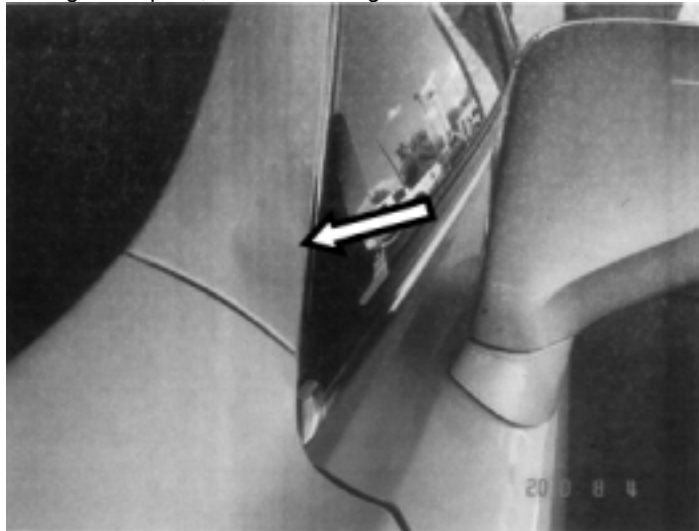
Case 1: This case arose from a sideswipe type accident in which contact was limited to only mirror-to-mirror contact between two vehicles. The side mirror of the subject vehicle was struck and folded forward, striking the A-pillar, as shown in Figure 1.

Figure 1: Damage due to mirror-to-mirror contact.

In order to determine the accelerations experienced by the vehicle and its occupant, three vehicles were used to measure the force required to fold their side-view mirrors forward. The force ranged between 9 and 12 pounds, which corresponded to about $1/50^{\text{th}}$ of 1g or a Delta V less than $1/20^{\text{th}}$ of one mph for the subject vehicle. For comparison, as shown in Figure 2, the longitudinal vehicle accelerations associated with normal driving were measured as a vehicle was driving on a normal roadway prior to a steering-induced rollover and were about $1/4^{\text{th}}$ of one g. As such, the forces and accelerations which the vehicle and the occupant were subjected to were far less than those associated with vehicle vibrations while driving normally.

Thus, with contact limited to only mirror-to-mirror contact, the occupant would not be able to discern the contact from the vehicle vibrations associated with normal driving, other than the sound of the mirror contact.

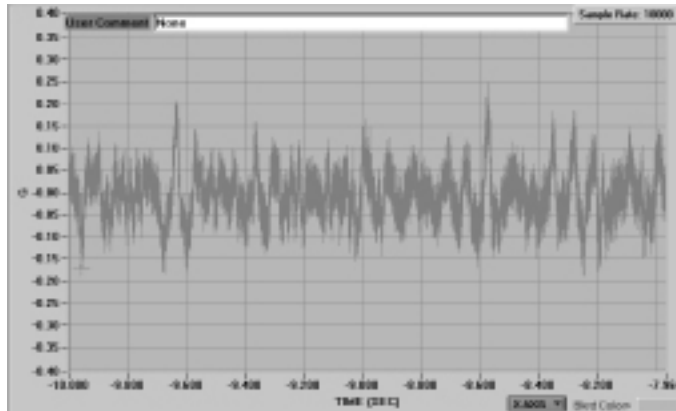
Figure 2: Longitudinal acceleration trace under normal driving conditions.

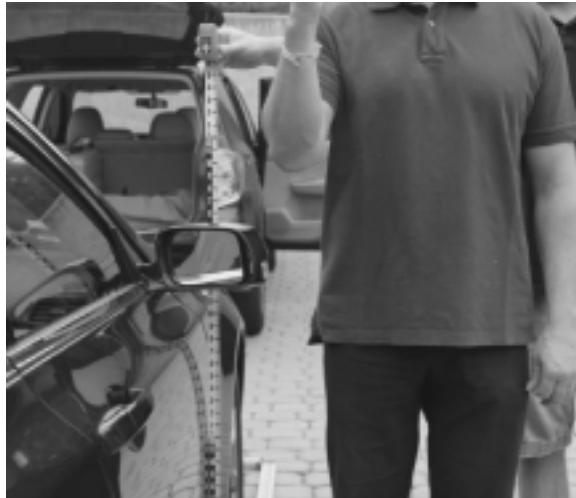
Case 2: This case arose from a vehicle versus pedestrian accident in which the pedestrian claimed that the vehicle's side-view mirror struck the pedestrian's right elbow resulting in injury. Video surveillance determined the speed of the vehicle to be between 11 and 13 mph as it passed the pedestrian. Interestingly, as shown in Figure 3, the height of the pedestrian combined with the pedestrian's forearm being raised holding a video camera was found to prevent direct mirror to elbow contact. In addition, surveillance video analysis showed that the mirror was not rotated rearward as it passed the pedestrian. The force necessary to fold the subject vehicle's mirrors was measured to be between about 11½ and 15 pounds. Certainly, had the vehicle's side-view mirror had significant contact to the bony structures of the pedestrian's arm as it passed at 11 to 13 mph, the side-view mirror would have been expected to fold rearward.

Figure 3: Surrogate demonstrating arm-to-mirror clearance
