C23 *In Situ* Hardening of a Steel Tank: Carbon Diffusion Over 35 Years at Ambient Temperatures

Anastasia Micheals, MS*, Forensic Materials Consulting, 1784 Sanchez Street, San Francisco, CA 94131-2741

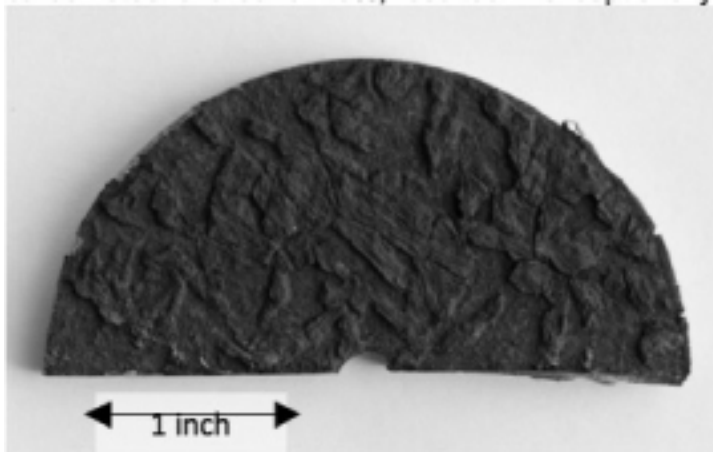
Uncleaned A, under the optical microscope (Figure 1), showed a cracked coal tar pitch epoxy coating. In some areas, the coating had spalled away and red iron oxide scale formed. Under SEM, a region containing both coating and corrosion was examined (Figure 2). The corrosion had a typical iron oxide appearance (Figure 3). The coal tar coating (Figure 4) showed some surface deposits and surface cracks.

Figure 1. Water tank specimen, Piece A, no cleaning.

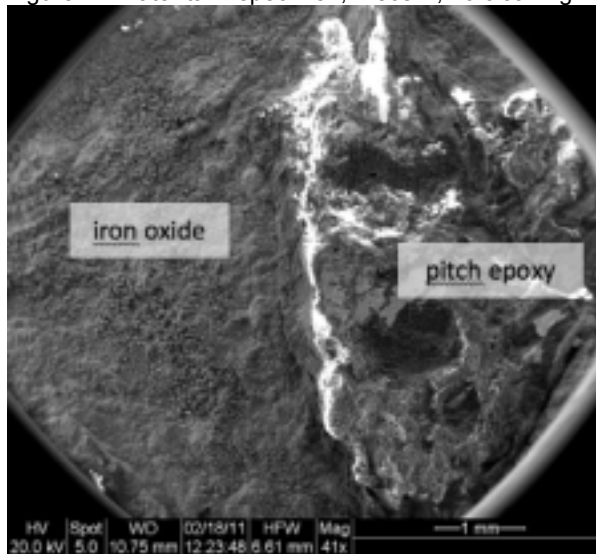
Figure 2. Electron micrograph of A, in a region with both red iron oxide corrosion and pitch epoxy coating.

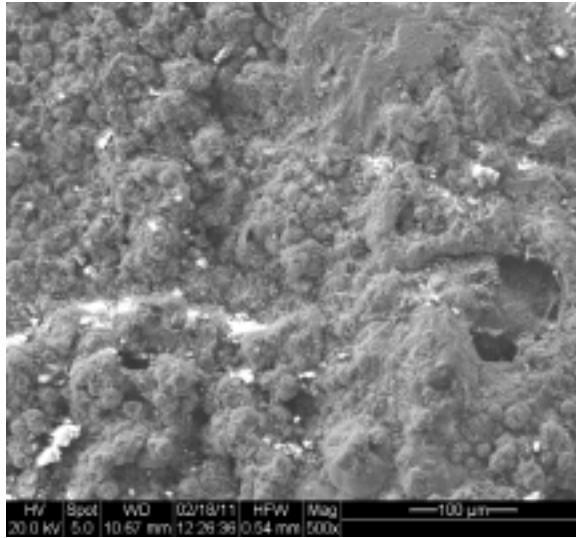
Figure 3. Electron micrograph of corrosion from A. The bubbles are typical of rust; EDS analysis confirmed the composition of the rust to be Fe_2O_3 .

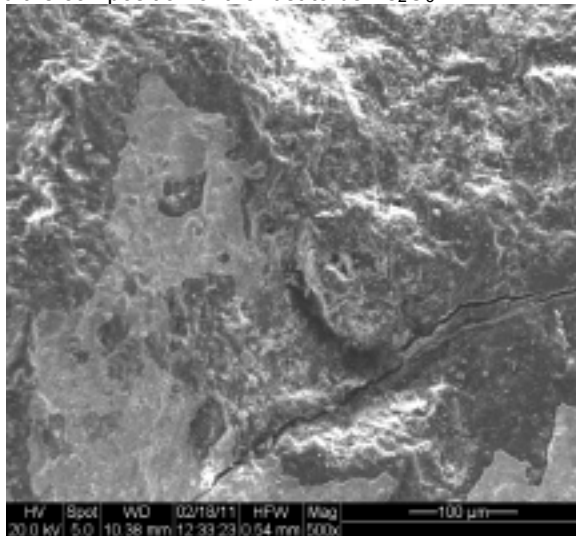
Figure 4. Electron micrograph of the pitch epoxy coating from A. The light areas are surface deposits. The crack is typical of those found in the coating.

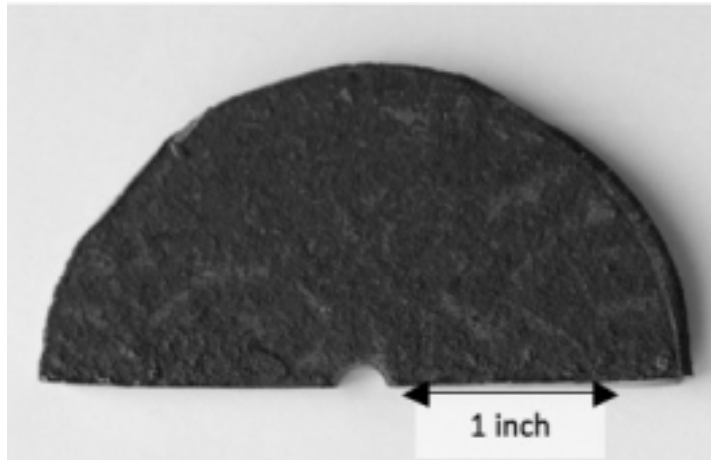
Optical microscopy of B showed that the sweep blasting, while incomplete, had removed most of the coal tar coating (Figure 4). Residual red iron oxide and black regions consistent with the coal tar coating seen on the uncleaned piece were found. Piece B was examined in the SEM. The surface was somewhat rough, indicating incomplete sweep blasting. EDS of the area again revealed no unexpected elements.

Figure 4. Water tank specimen, Piece B, sweep blasted.

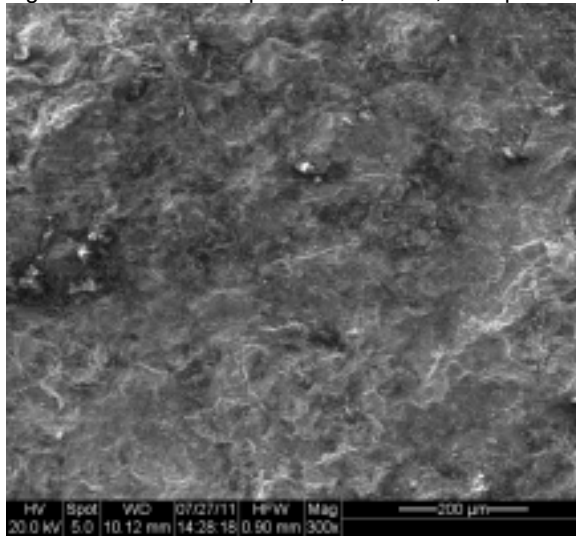
Figure 5. Electron micrograph of B. The rough surface is a result of sweep blasting with steel abrasive, which did not penetrate to the steel substrate.

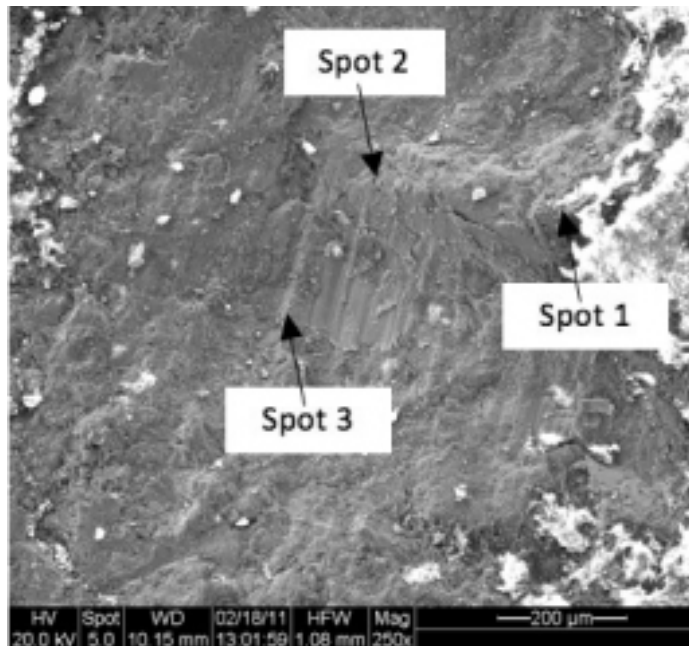
Figure 6. Area of EDS analysis.

Spot elemental analysis was performed on an area of sweep-blasted B, where a cross-section from the pitch coating to the bare steel was visible (Figure 6) at three locations; pitch coating, mid coating, and bare steel (Table 1.). The additional elements detected, likely deposits from groundwater, were silicon, calcium, aluminum, magnesium, potassium, sulfur, and chlorine.

At Spot 1, the top of the coating, carbon from the coal tar pitch epoxy was detected. Hydrogen was also likely present, although EDS cannot detect it. At Spot 2, a significant amount of iron was detected. The ratio of iron to oxygen was approximately 1:1, which suggests iron oxide of the form FeO, a black oxide. The presence of carbon suggests carbon diffusion into the iron oxide. At Spot 3, the primary element present was iron.

Piece B reveals a second process, carbon diffusion. Carbon will readily diffuse into iron, at a rate dependent on temperature. The carbon gradient discovered in Piece B indicates that the carbon diffusion process has been taking place over the 35-year lifetime of the tank. Although the maximum ambient temperature was relatively low ($\sim 100^\circ\text{F}$), the long time allowed significant carbon diffusion to occur, causing surface hardening of the low carbon steel. This diffusion rate was verified by Fick's Second Law.

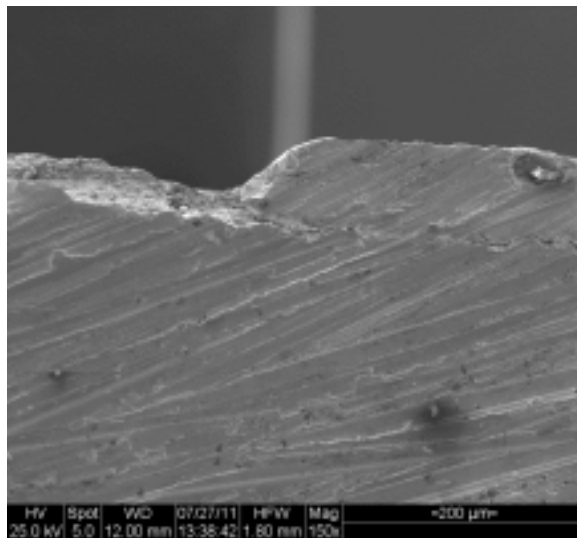
Piece A is representative of the present condition of this 35-year-old tank and coal tar coating. Over time, volatile organic compounds evaporated from the pitch, causing it to lose elasticity. Cracks in the coating then initiated and grew. Water penetrated through the cracks to the steel and formed ferrous oxide (FeO), the iron corrosion that forms in limited-oxygen environments. The corrosion propagated underneath the coating (Figure 7), allowing spallation. The iron, then exposed to oxygen, converted from black FeO to

Figure 7. This cross section shows the propagation of corrosion beneath the coating.
