C12 Breakage Characteristics of Glass Drinking Vessels and Consequent Injury Potential in "Glassing" Attacks

Richard W. Earp, MEng*, Dept of Engineering, Univ of Leicester, University Rd, Leicester, Leicestershire LE1 7RH, UNITED KINGDOM; Sarah V. Hainsworth, PhD, Dept of Engineering, Leicester, LE1 7RH, UNITED KINGDOM; and Malcolm D. Glendenning, PhD, Glass Technology Services, 9 Churchill Way, Chapeltown, Sheffield, South Yorkshire S35 2PY, UNITED KINGDOM

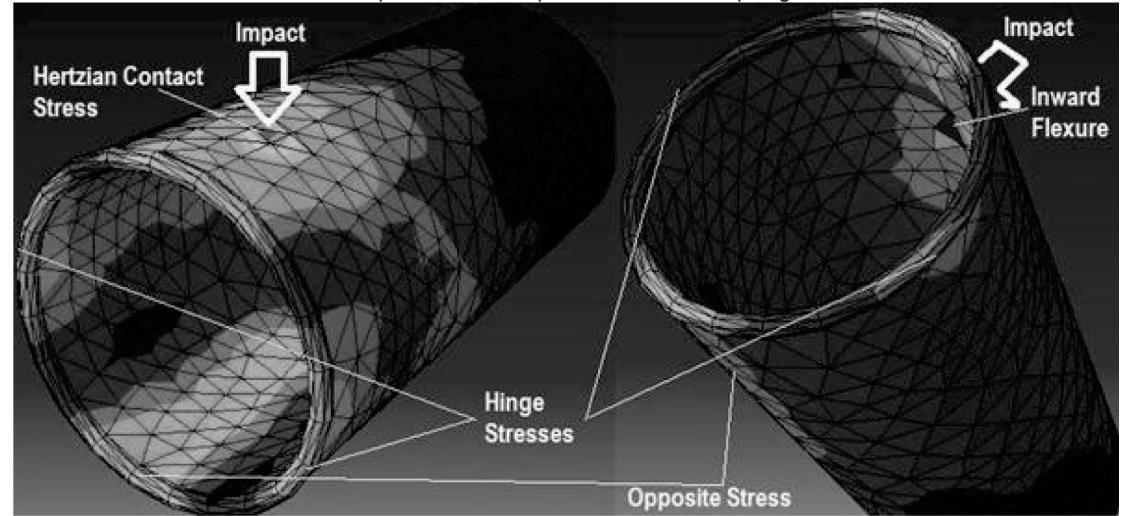
Figure 1 shows a Finite Element Analysis (FEA) simulation of a pint glass subject to impact. Areas of high stress concentration are likely to serve as the origin of failure but more vulnerable areas of the glass (i.e., the rim) are likely to be the source of the most severe flaws. Failure occurs when the critical fracture toughness is exceeded. Where a large flaw is found, the energy necessary to cause fracture is low and a claim of accidental breakage and consequent injury may have merit.

Figure 1 — Finite element simulation of stress distribution on a straight-walled pint glass due to impact. Left image shows the Von Mises stress distribution, right image shows first principal stresses.

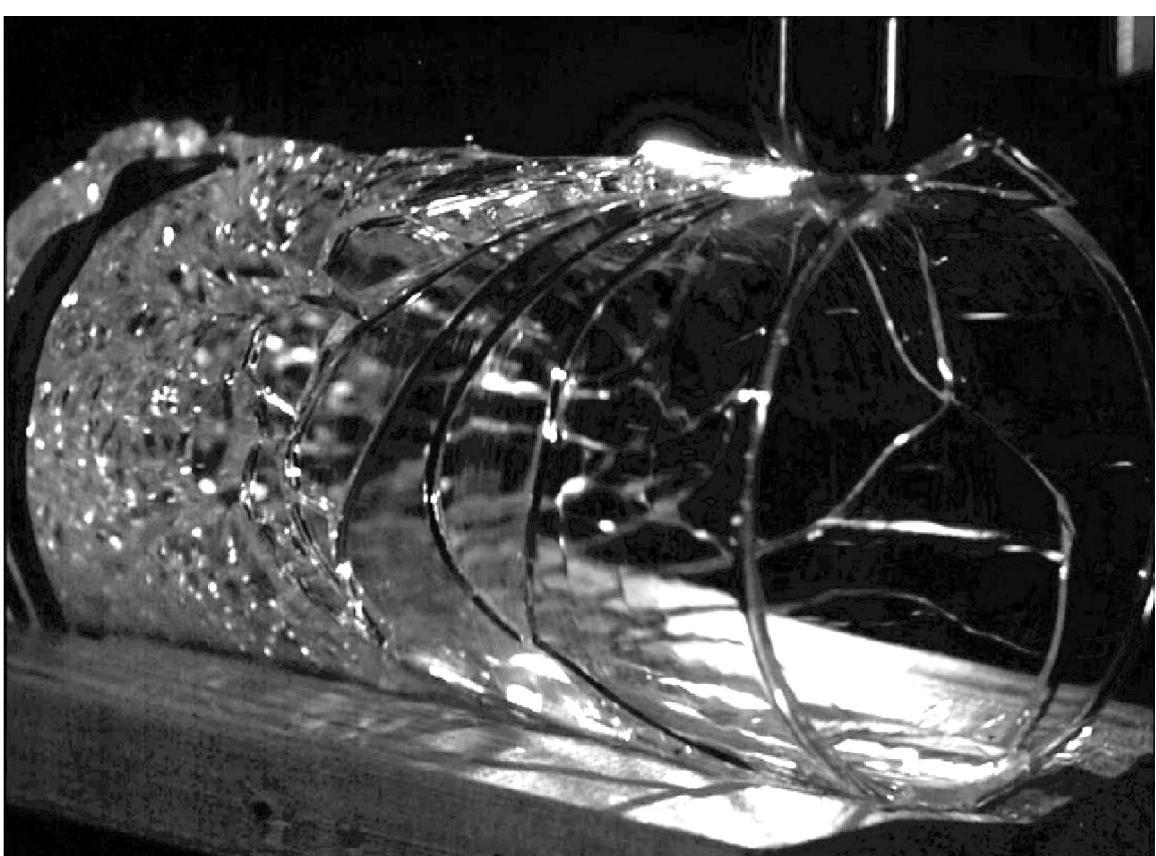
However, the level of temper possible is dependent upon the thickness of the glass and it is found that thinner parts of the glass (i.e., closer to the rim) store far less stress and resulting fragments there are similar to that of annealed (residual stress-free) glass. This can be seen in Figure 2.

Figure 2 — A frame taken from high-speed video footage of a tempered glass fracture. Near the base of the glass, the toughening process is effective and the glass breaks into small shards. For this glass, toughening is less effective closer to the rim, resulting in larger and sharper shards. **Glass, Glassing, Fragment**
