C8 Human Factors Evaluation of a Steam Shower

Alison G. Vredenburg, PhD*, and Michael J. Vredenburg, Vredenburg & Associates, Inc., 2588 El Camino Real, F-353, Carlsbad, CA 92008

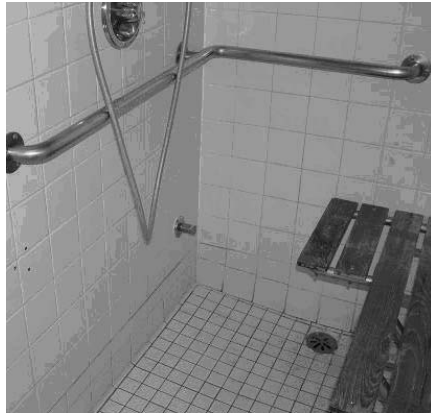
In front of the bench seat is a steam outlet pipe (see Figure 1), approximately 12" above the floor and 18" from the seat. On the wall perpendicular to the seat (approximately 4 feet from the seat) was the thermostat vent (see Figure 2) located six feet high with "THERASTEAM" embossed across the front.

Figure 1. Steam shower seat area (outlet pipe indicated)

Plaintiff contended that the thermostat vent was the steam outlet. In actuality, the outlet pipe projected from the wall opposite the bench. The Owner's manual instructed, "Install steam head [outlet pipe] 18" above shower floor. The steam head should be located as far from the seating area as possible *for bather's comfort*." No written warning described the safety hazard to the user if the steam head was installed near the seating area.

To evaluate the reasonableness of Plaintiff's belief that the thermostat sensor was the steam outlet, participants were asked to refer to photographs and identify the thermostat vent ("Please tell me what this object [pointing] is"), steam outlet pipe, and several items used as distracters (bench, shower hose, and handrail). Consistent with Plaintiff's perception, 88% of the study participants also misidentified the thermostat vent as the steam outlet while only 8% recognized it as a thermostat or sensor. Similarly, 8% of the participants correctly identified the steam outlet pipe.

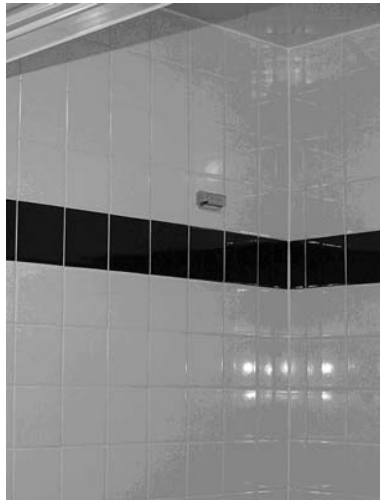
Figure 2. Thermostat vent Human Factors, Perceptions, User Interface
