Engineering Sciences Section – 2011

C5 Forensic Examination of an Unwanted Seat Belt Release in a Rollover Collision With Occupant Ejection

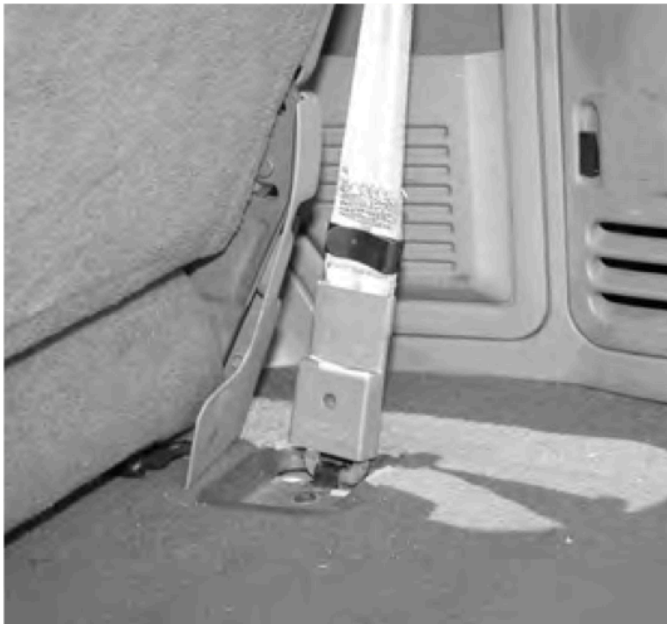
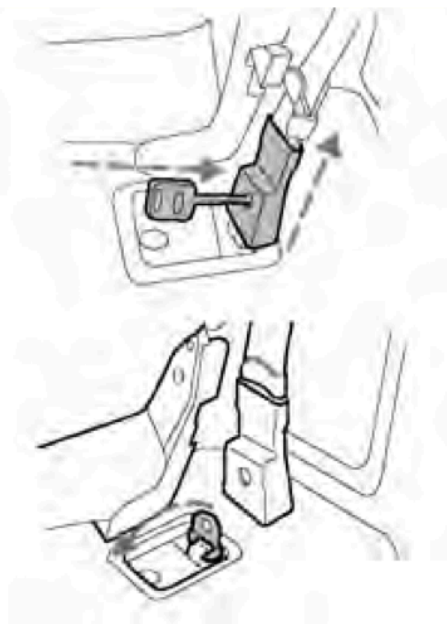
Third Row Outboard Seat Belt Design: The 3rd row, outboard seat belt assemblies feature continuous loop webbing, a free-sliding latch plate, fixed D-ring and an emergency-locking retractor. The seat belt assemblies contain a seat-fixed, end-release buckle and a lower outboard detachable anchor. These design features facilitate the complete removal of the third row seat assembly to expand cargo volume. The 1998 through 2002 model year Ford Expeditions and Lincoln Navigators contain the same third row detachable anchor design. The detachable anchor resembles a side-release seat belt buckle encased in a plastic boot (photo 01 detachable anchor). The other side of the detachable anchor is called the anchor tongue, and resembles a chrome-plated latch plate tongue that is secured to the vehicle inside a recessed floor pocket. The Expedition Owner's Guide explains how to disengage the lap-shoulder belt from the floor: Insert a key or small screwdriver through a hole in the boot, press on the release button, thereby separating the detachable anchor from the anchor tongue (figure 01 illustration). During the inspection of the subject vehicle, the detachable anchor of the right third row outboard seat belt assembly was found detached from the anchor tongue.

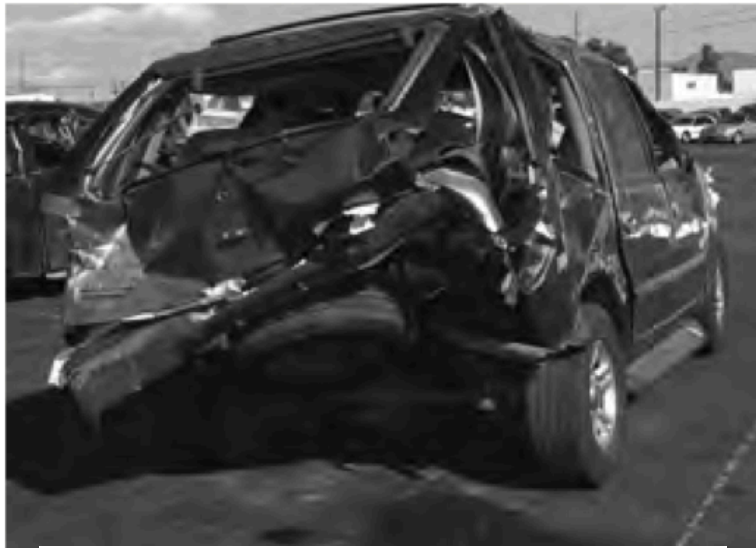
Third Row Outboard Seat Belt Release Mechanism: The impact by the Ram caused the Expedition's right rear floor structure to deform upward toward the headliner (photo 02 rear corner damage). Deformation to the area surrounding the detachable anchor was significant enough to allow the detachable anchor to contact the outboard seat back recline lever. In the undeformed condition, the hole in the boot is approximately four inches from the lower edge of the recline lever when the seat belt is fastened. Scratches consistent with interaction with the recline lever were visible on the side of the boot that conceals the release button facing

the lever (photo 03 boot evidence). The boot also showed evidence of being compressed in the form of discoloration or lightening of the plastic. The physical evidence indicated that it was most likely interaction between the seat back release lever and the plastic boot that led to an unintended release of the detachable anchor.

Physical evidence on the third row, right outboard seat belt detachable anchor suggested that interaction with the seat back recline lever led to unwanted release of the seat belt.
