C30 The Cause Analysis of a Farm Tractor and Motor Grader Collision Fatality: A Case Study

Kurt D. Weiss, MS, Automotive Safety Research, 5350 Hollister Avenue, Ste D, Santa Barbara, CA 93111-2326*

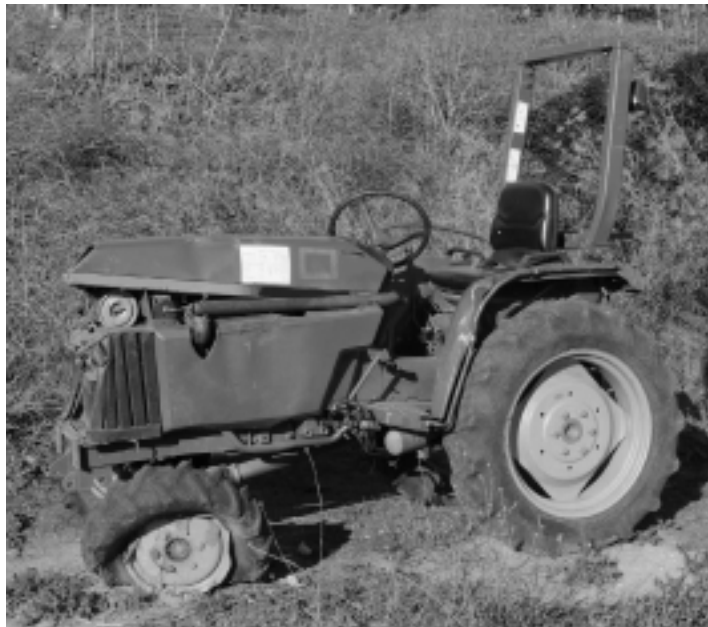
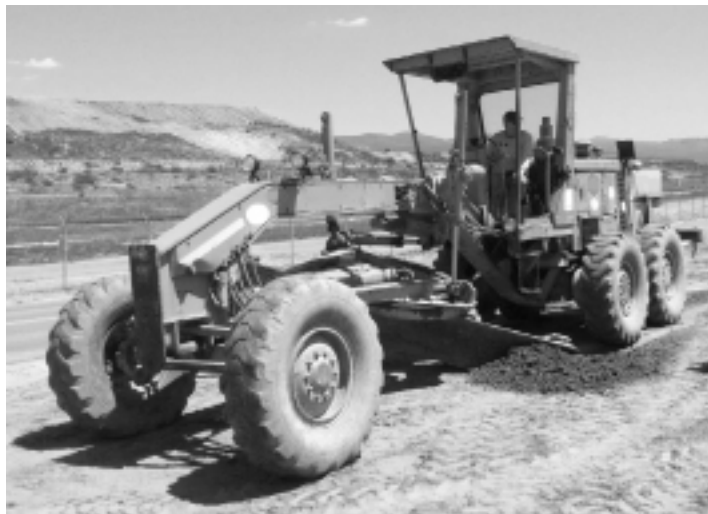
A compact 1,900lb utility tractor commonly used in vineyard service was impacted by a 19,500lb motor grader. The tractor operator was ejected and killed. A forensic analysis was performed to determine the cause of the collision.

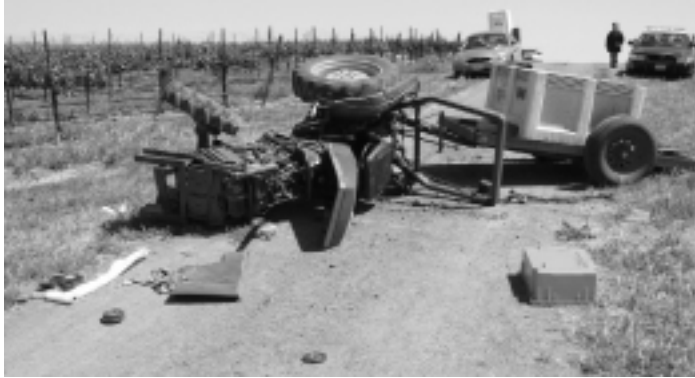
It is unknown if the tractor operator was wearing full-coverage ear protection at the time, though it is unlikely this operator was aware that the grader had previously graded service roads at an adjacent site and was now in transition to another location. The grader's course on the service road intersected that of the tractor while negotiating its U-turn.

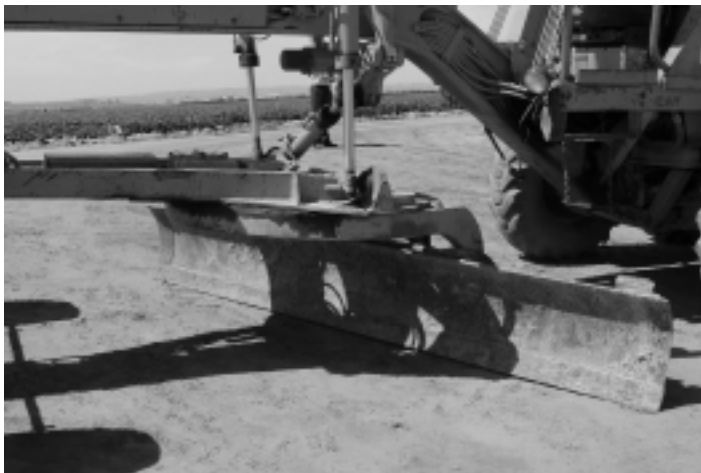
A late attempt at collision avoidance was initiated by the grader operator attempting to steer around the tractor. The collision knocked the tractor over onto its left side, and the operator was ejected. Physical evidence shows that the tractor operator was not wearing a lap belt. The grader's left front wheel mounted and rolled over the tractor, then over the operator, causing fatal head injuries. The grader continued down a slight decline for another 140ft after the operator dropped the grading blade as a means to stop the grader whose engine had apparently stalled.

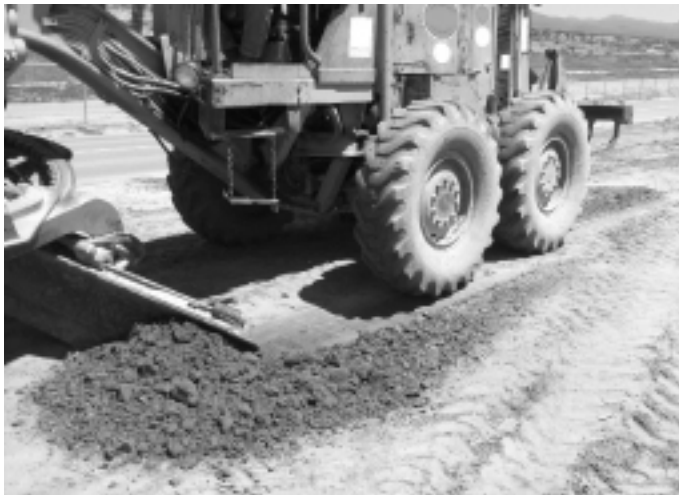
A third test series was designed to measure the stopping distance and deceleration rate by only lowering the blade as a means to stop the grader. Three tests conducted at approximately 11mph demonstrated stopping distances of 12.3, 8.5, and 11.8ft, respectively. The average deceleration for these tests was 0.154, 0.148, and 0.176g, respectively. A fourth test conducted at 17.3mph, resulted in a stopping distance of about 23.8ft, with an average deceleration of 0.262g.

A time-position analysis of the grader at 17mph showed it was approximately 14sec from impact when the tractor was reasonably expected to be in view. Assuming a 2sec perception/reaction time, and allowing 2sec for the grading blade to make soil contact, the grader operator could have stopped in about 125ft. Therefore, it was argued that the grader operator had failed to use precious time available to avoid the collision.
