## D52 Sideswipe Evidence for Traffic Accident Reconstruction

The goal of this presentation is to present physical evidence that can be found on vehicles involved in sideswipe accidents to assist in the reconstruction of these types of vehicle accidents.

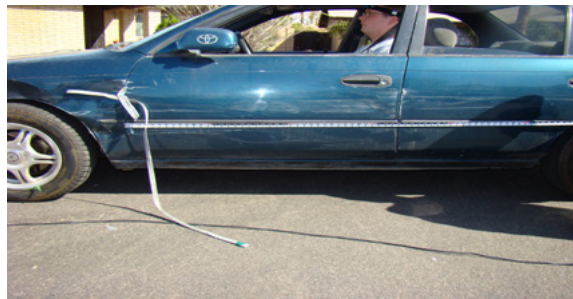
Figure 1: Typical sideswipe damage with side view mirror rotated rearward (overtaking vehicle).

Physical evidence including material flow, sheet metal deformation, pocketing, mirror rotation and damage, rubber transfer, and closing of body panel gaps are some examples of physical evidence that can show which vehicle was overtaking the other. Figure 1 depicts most of these examples from a sideswipe demonstration performed by researchers in which this vehicle was overtaking the other during the contact.

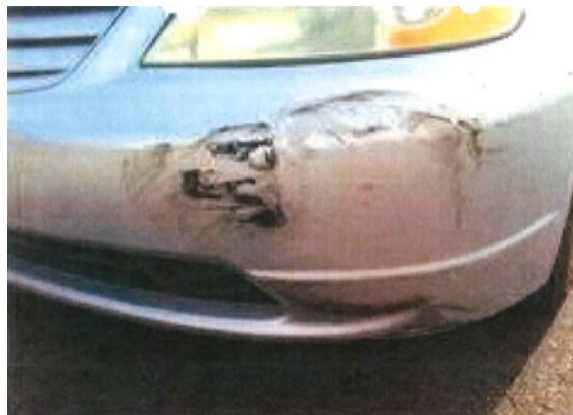
Figure 2: Material flow from vehicle passing from passenger's to driver's side.

Material flow can usually be found on plastic components such as door moldings, wheel opening moldings, and bumper covers. When the plastic component is contacted by the other vehicle, the plastic may be scraped and displaced toward the direction of contact. As shown in Figure 2, although located on the front bumper, the material flow from tire and rim contact was toward the driver's side, showing that the contacting vehicle was traveling from the passenger's side toward the driver's side during the contact.

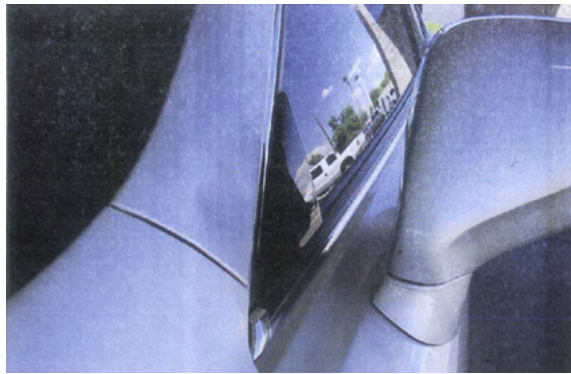
*Figure 4: Mirror strike from forward rotating mirror housing.*

*Mirror rotation and damage* can occur when the side view mirror is contacted during the contact. Paint or plastic scuffing can usually be found on the leading edge of the mirror housing on the front or rear of the housing indicating which side of the mirror was contacted. The mirror is sometimes able to rotate, sometimes contacting the A-pillar, indicating direction. Figure 4 depicts mirror contact to an A-pillar from the mirror rotating forward from contact from an overtaking vehicle.

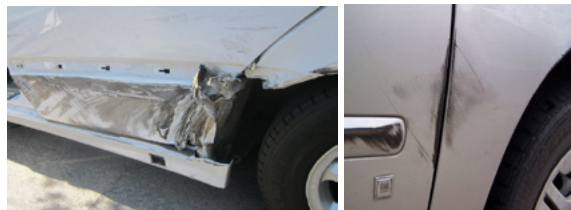
*Figure 5: Examples of rubber transfer evidence.*

*Rubber Transfer* can be indicative of tire contact. Figure 5 depicts examples of rubber transfer. The striations shown are evidence of contact with a spinning tire.

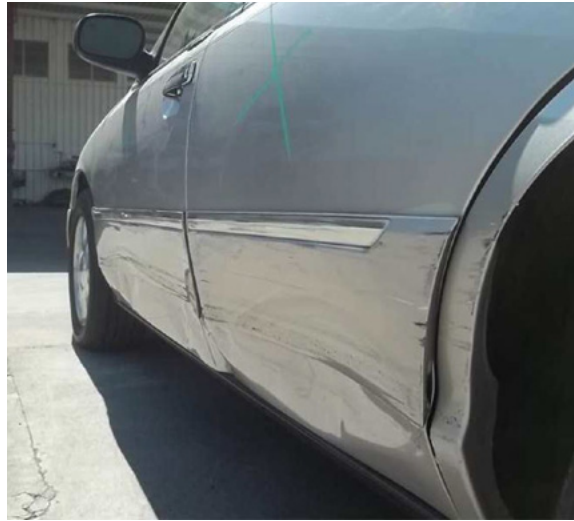
*Figure 6: Example of closing of body panel gaps.*

*Closing of body panel gaps* can occur when the sheet metal is deformed and moved forward or rearward due to contact with the other vehicle. An example of a closed body panel gap is shown in Figure 6, where the left rear door panel was deformed rearward closing the gap.
