D39 Shared Anchor Seat Belt Buckle Self-Release

Kurt D. Weiss, MS*, Automotive Safety Research, Santa Barbara, CA 93111-2326

Learning Overview: After attending this presentation, attendees will understand about a seat belt-restrained occupant in a Sports Utility Vehicle (SUV) who was ejected and fatally injured in a rollover collision. The physical evidence will be detailed, and the mechanism of inadvertent seat belt buckle release will be clearly explained.

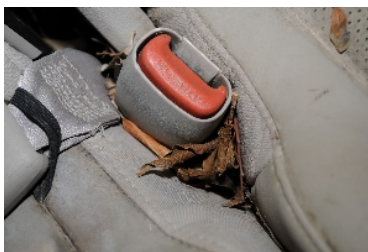
Closer examination revealed curious artifacts to the plastic cover of the left buckle.

Furthermore, the lower corner of the adjacent center buckle has a smaller diameter than the balls used in resistance to opening testing. Several new exemplar components were obtained and tested. The elongation of the attachment webbing of the center buckle under reasonably anticipated tensile forces was demonstrated. Alignment of the buckle housing allowed for its lower corner to interact with the adjacent left buckle. Therefore, it was correctly concluded that interaction of the adjacent buckles in use at the time of collision caused inadvertent buckle release that resulted in the ejection and fatal injury of the second-row left-seated occupant.
