D20 Evaluating the Effect of the Crash Locking Tongue on the Breaking Strength of Seat Belt Webbing

Kurt D. Weiss, MS, Case Study Collision Science, LLC, Santa Barbara, CA 93190*

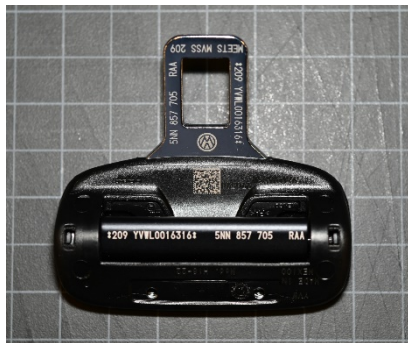
Figure 2 - The Crash Locking Tongue of the 2018 Volkswagen Tiguan.

Federal Motor Vehicle Safety Standards (FMVSS) 209 S4.4(b)(6) requirements for type-2 assembly performance hardware specifies that any webbing cut by the hardware shall have a breaking strength of not less than 15,569N for the lap belt or not less than 12,455N for the shoulder belt. In this study, separation occurred at the CLT with peak lap belt webbing loads between approximately 6,993N and 8,203N (SD 512N) and peak shoulder belt webbing loads of between approximately 10,280N and 11,521N (SD 519N). Pre-loading the lap belt (which occurs with sill-end pretensioner activation) caused the CLT to clamp the webbing. The clamping edge of the CLT appears to have caused the webbing separation.

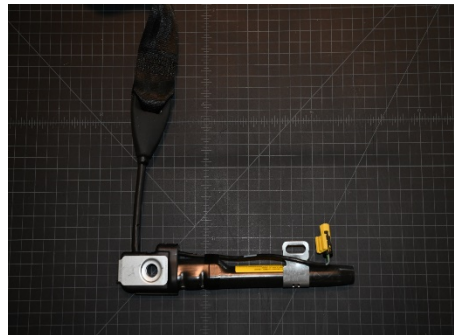
Figure 1 - The front outboard seat belt sill-end pretensioner of the 2018 Volkswagen Tiguan.

Testing was performed on new seat belt assemblies to investigate the effect of the CLT design on reducing the breaking strength of the webbing. The type-2, dual-pretensioner (sill-end and retractor) assembly features 47mm-wide polyester webbing and a dual-locking, switchable load-limiting retractor. The sill-end pretensioner is capable of producing a peak force of approximately 6,228N in the lap belt (Figure 2). Three-point anchoring held the seat belt webbing in a "V" shape with an included angle of approximately 45 degrees, similar to in-vehicle geometry (Figure 3). The end of the lap belt webbing was held using the stitched loop end for the first test and subsequently by a split-drum grip. The lap belt was preloaded to between approximately 3,959N and 4,448N. The latch plate tongue was held by a clevis pin. The end of the shoulder belt webbing was held by a split-drum grip secured to a hydraulic cylinder. The shoulder belt web-grip displacement rate was between approximately 89 and 94mm/s. Data was sampled at 1,000Hz.
