### **C21 Air Conditioner Compressor Blasts Taking Lives in India: A Forensic Analysis**

*Jatin Bodwal, MBBS, MD\*, Maulana Azad Medical College, Dept of Forensic Medicine, Bahadur Shah Zafar Marg, New Delhi 110002, INDIA; Chittaranjan Behera, MD, Department of Forensic Medicine, AIIMS, Ansarinagar, New Delhi 110029, INDIA; and Mohit Chauhan, MBBS, Department of Forensic Medicine, Maulana Azad Medical College, Bahadur Shah Zafar Marg, New Delhi, Delhi 110002, INDIA*

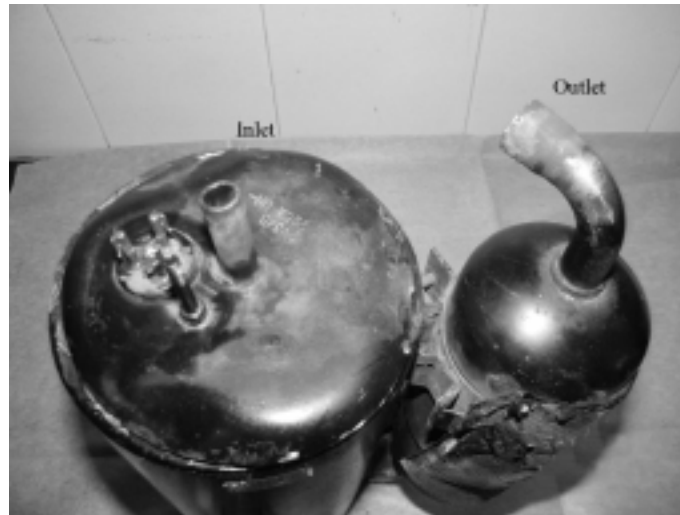
Figure 1: AC compressor showing inlet and outlet.

The focus of this presentation is on the workings of the compressor for the AC unit. The compressor is actually a large electric pump that pressurizes the refrigerant gas as part of the process of turning it back into a liquid. A typical AC compressor has two openings in the form of an inlet and an outlet (Figure 1).

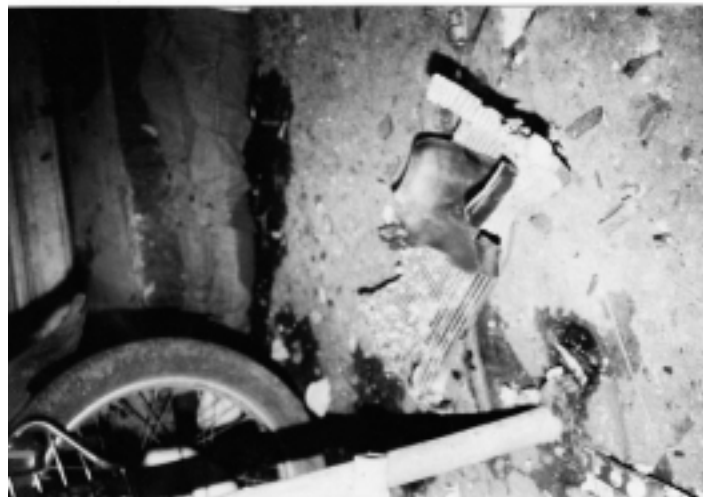
Fig. 2: Remnant of compressor (black in color) at blast site.

The chief reason for AC compressor blast is extremely high pressure generated inadvertently by the use of dry nitrogen inside the compressor chamber while checking for leaks. Normally, AC compressors are capable of functioning at gauge pressure of about 1,000 pascals, but when it rises dangerously to 2,000 pascals, then a blast occurs. Most of the modern sophisticated compressors are equipped with safety valves which function to alleviate excess pressure. If the valve becomes dysfunctional due to a clogged pipe or if the compressor is not equipped with safety valves, then excess pressure causes the compressor blast.

In this instance, when the repairman reached the jewelry shop, he was allegedly unaware of the fact that the compressor had already been, filled with dry nitrogen by another repairman prior to his visit. The moment he asked to switch on the AC unit, the blast occurred. Figure 2 shows the remnant of the compressor at the site. The blast was of such high intensity that a substantial part of his skull was blown off and all brain matter was discharged (Figure 3).
